Highway 141 STEP Study

Prepared For:
Arkansas Department of Transportation
October 2019

HIGHWAY 141 STEP INNOVATION STUDY (Jonesboro) (S)

FINAL TRAFFIC REPORT

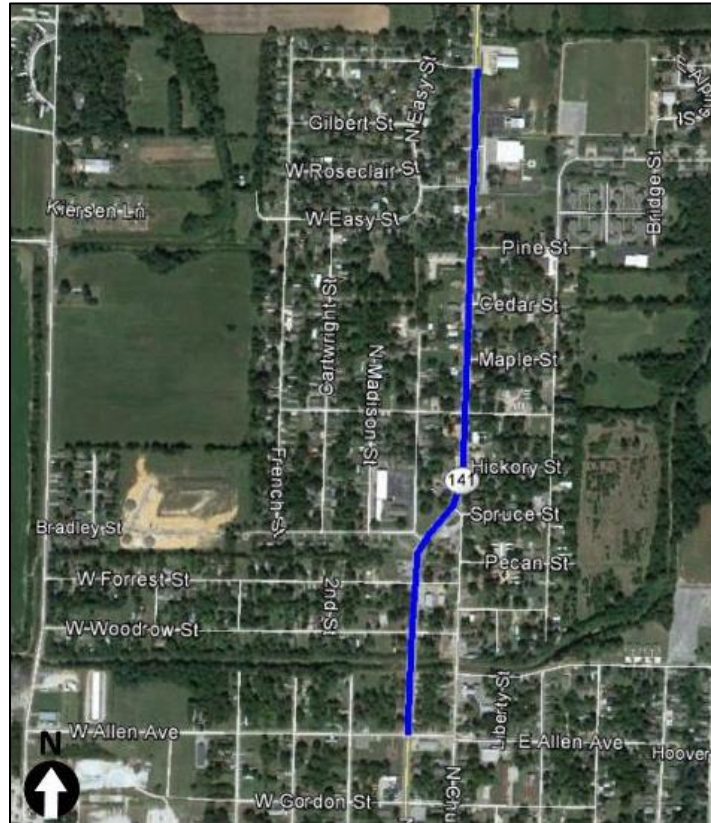
Figure 1: Highway 141 Study Corridor

Highway 141, also known as N. Church Street, serves as a minor arterial facility through Jonesboro. The study area extends from Allen Avenue on the south end to Alpine Street on the north end, and the majority of the corridor has a posted speed limit of 40 miles per hour. (A small portion of the study area just north of Allen Avenue has a posted speed limit of 35 mph.) Highway 141 contains four traffic lanes with no shoulders and sidewalks mostly on the east side of the road. Two bus stops are located within the study area: one between Woodrow Street and Forrest Street, and one at Novak Street. Google Maps and the JETS Route 37 map show a third bus stop at Center Street, but no evidence of a third bus stop was observed during the site visit. A map of the study corridor is shown in **Figure 1** on the following page.

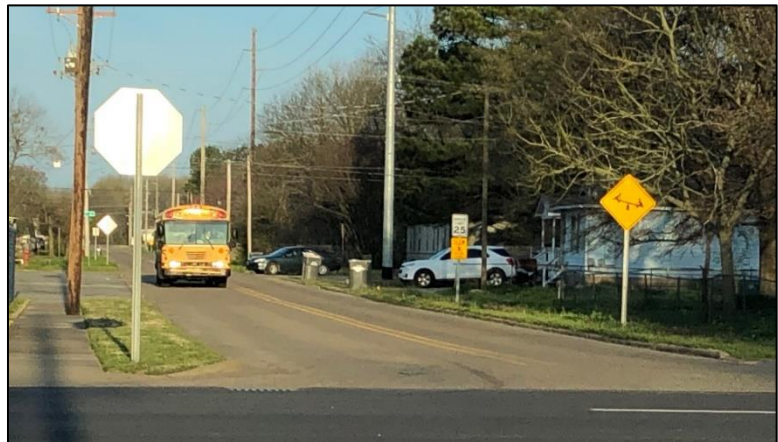
Figure 2: School Bus Loading on Allen Avenue

Vehicles drive about 40 miles per hour throughout the corridor even during the rush hours. No excessive speeding was noted. Several school buses drive through this area, especially during the AM peak period. The school buses do not load or

unload on Highway 141, but they were observed to load and unload on Allen Avenue next to the park on the west side of Highway 141, as shown in **Figure 2**.

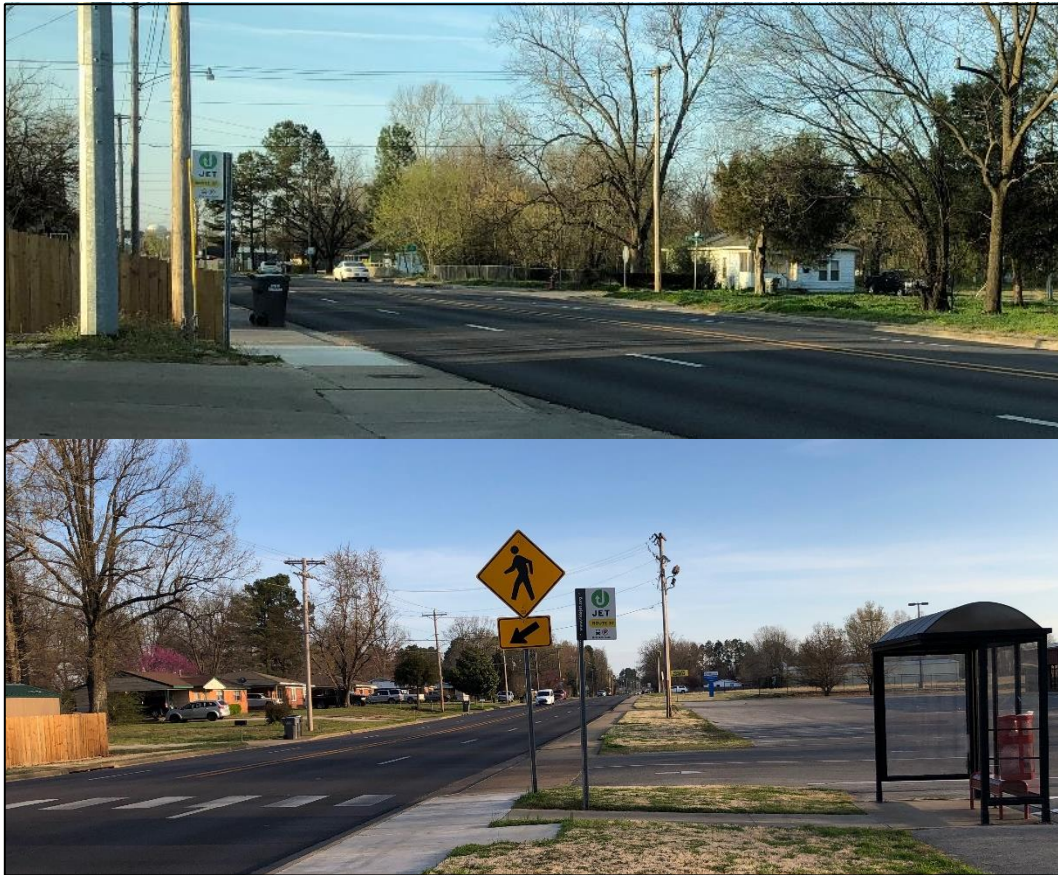
Figure 3: JET Bus Stops

Two JET bus stop locations exist within the study area: between Woodrow Street and Forrest Street, and at Novak Street. As shown in **Figure 3**, the bus stop between Woodrow Street and Forrest Street (pictured on top of page 8) lacks a bench and pedestrian refuge. Additionally, no designated crosswalks are provided near this bus stop. The bus stop at Novak Street (pictured on bottom of page 8) has a bench within a pedestrian refuge and has a designated crosswalk across Highway 141. However, this crossing lacks wheelchair ramps on either side of the crosswalk and also lacks sidewalk on the western side of Highway 141.

- Provide continuous sidewalk along the west side of Highway 141 throughout the study corridor.
- Provide wheelchair ramps, stop bars, and proper alignment of the pedestrian facilities at the Novak Street crosswalk.
- Provide a bench and refuge area at the bus stop between Woodrow Street and Forrest Street.

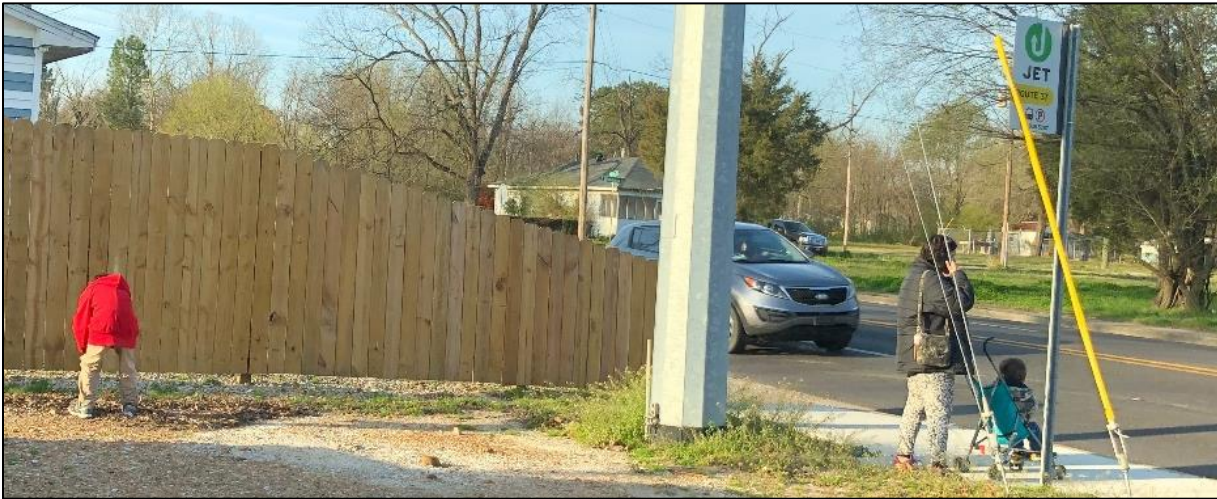
Figure 4: Lack of Accommodations at Southern Bus Stop

The JET buses were observed to come through the corridor twice an hour (at approximately 18 minutes and at 48 minutes past the hour). However, these buses did not slow down or stop unless a person was standing directly at the bus stop sign. When pedestrians were standing near but not at the sign, the buses passed by without even slowing. While this avoids undue delays, this does present one concern. As mentioned above, the bus stop between Woodrow Street and Forrest Street lacks a pedestrian shelter or bench, and it is very near to the traffic lane. During the AM peak observations, a mother and her small children, shown in **Figure 4**, were observed waiting at this bus stop. The mother had difficulty maintaining the safety of her children while staying

directly at the bus stop sign. The children repeatedly wandered off even into the highway, forcing the mother to leave the bus stop sign to chase after them. Children observed at the Novak Street bus stop were more easily contained within the shelter area with the bench.

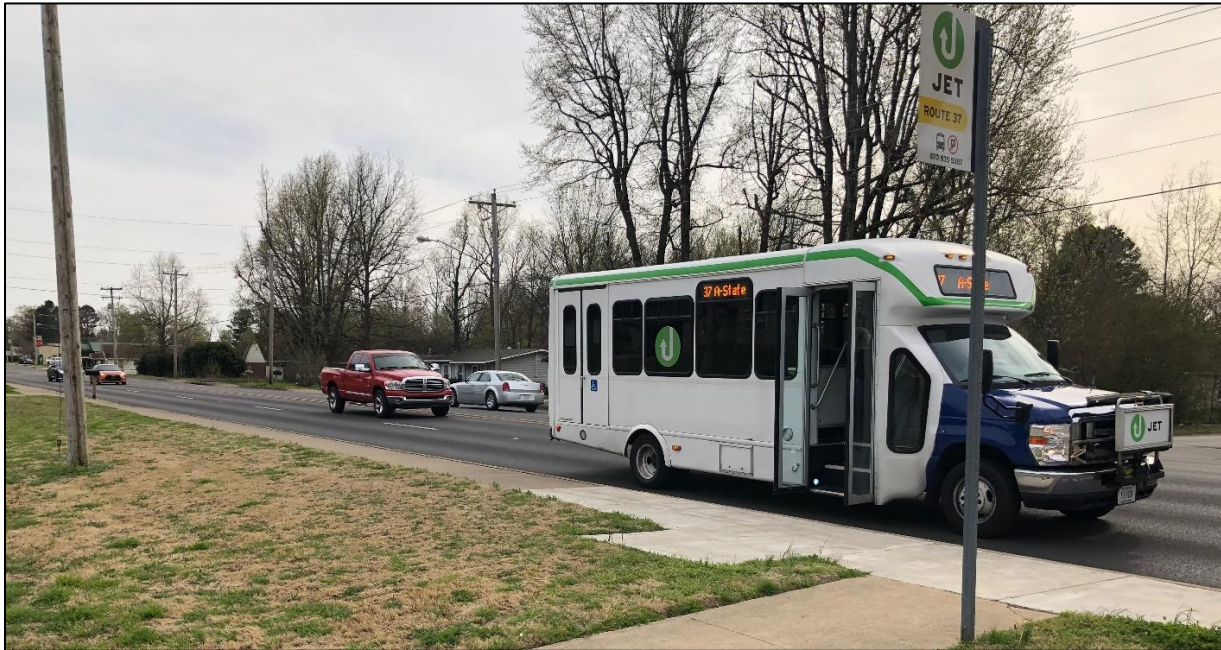
Figure 5: Bus Loading at Novak Street

No bus loadings were observed during the AM peak or the midday peak. Two bus loadings were observed at the Novak Street bus stop during the PM peak observations. Both times, the loading took approximately 1 minute even when one of the patrons mounted a bicycle on the front of the bus. As shown in **Figure 5**, traffic passed the bus in the inside lane without forming any queues. As the traffic passed, it slowed to approximately 15 mph.

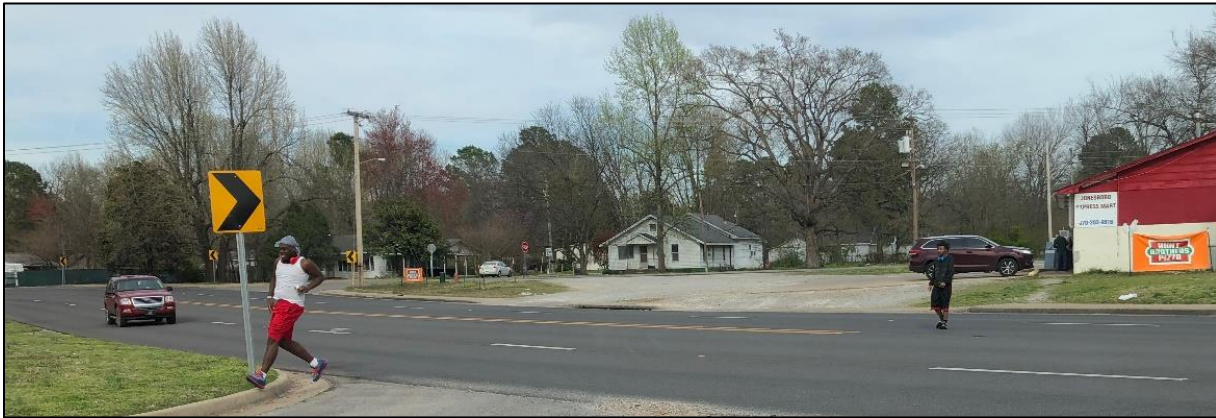
Figure 6: Pedestrians Crossing at Jonesboro Express Mart

During the AM peak, pedestrian and bicyclist activity was fairly low. Four pedestrians were observed crossing Highway 141 and three pedestrians were observed walking along the sidewalks on the eastern side of Highway 141 during this hour. All of these pedestrians were sited either by the bus stop between Woodrow Street and Forrest Street or near the Jonesboro Express Mart just north of Bradley Street. **Figure 6** shows two pedestrians crossing from the Jonesboro Express Mart to Bradley Street. As captured in this photo, the crossings often occur in groups. In many cases, the pedestrians run across Highway 141 to avoid vehicles. This is indicative of insufficient number of gaps in vehicular traffic of adequate length for safe pedestrian crossing. No bicyclists were observed during the AM peak hour.

During the site visit as well as the pedestrian counts, the area just north of Bradley Street near the Jonesboro Express Mart was observed to be one of the busiest pedestrian crossing locations within the study area. Therefore, this area was identified as the location which would benefit most from the installation of a PHB. Guidance from the *MUTCD* advises spacing a PHB at least 100 feet from driveways and side streets that are stop controlled. The distance between Bradley Street and Spruce Street is adequate

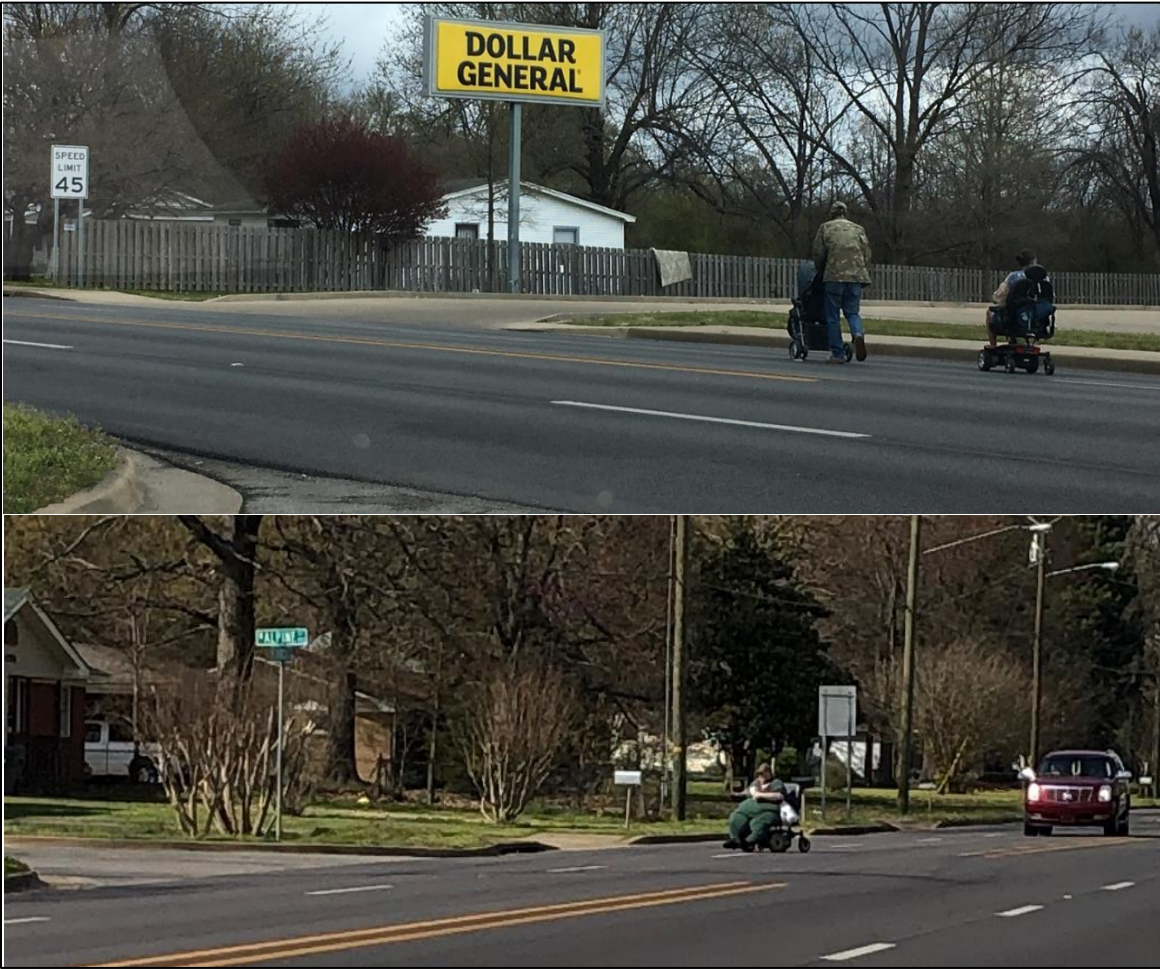
Figure 7: Pedestrians in Motorized Wheelchairs Crossing at Alpine Street

As shown in **Figure 7**, pedestrians using motor wheelchairs were observed crossing at Alpine Street on more than one occasion. Due to the lack of wheelchair ramps at this intersection, the pedestrians had to cross Highway 141 diagonally from the Dollar General parking lot, around the northwest curb of the intersection, to Alpine Street (or vice versa). During the first crossing incident, traffic along Highway 141 had to stop and wait for the pedestrian to clear the highway. These instances demonstrate a clear need

for pedestrian facilities at Alpine Street including wheelchair ramps, sidewalks on the west side of Highway 141, and a designated crosswalk. The *MUTCD* provides the following criteria for the installation of an unsignalized crosswalk along a roadway with four or more lanes and no raised median or refuge island: the speed limit does not exceed 40 mph and the ADT is less than 12,000 vpd. The northern end of the study area has a speed limit of 40 mph and an ADT of only 9,300 vpd, so an unsignalized crosswalk could be installed across Highway 141 at Alpine Street without violating *MUTCD* criteria.

- Add designated crosswalk locations between Bradley Street and Spruce Street and at Alpine Street. All designated crosswalk locations should be marked with high-visibility crosswalk markings, and they should have stop bars on both sides of the crosswalk, wheelchair ramps and sidewalks on both ends of the crosswalk, and advance “Yield Here” signs.

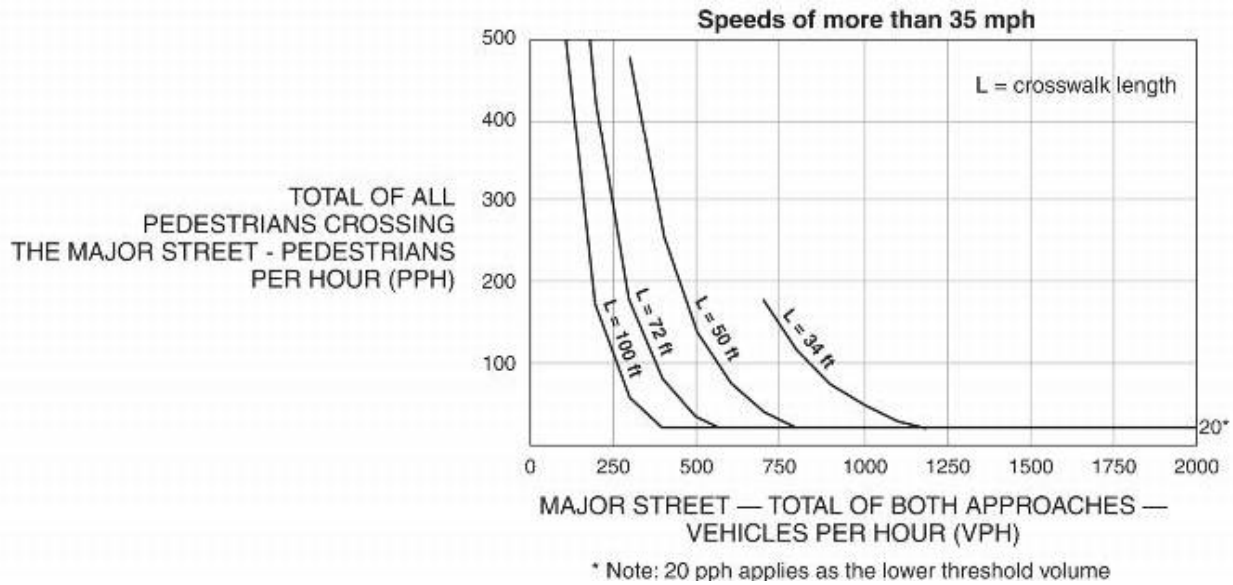
Figure 8: Guidelines for Installation of PHB (MUTCD Figure 4F-2)

The *Manual on Uniform Traffic Control Devices (MUTCD)* provides a table of guidelines for the installation of PHB on high-speed (35 mph or more) roadways as shown in **Figure 8**. These guidelines are not meant as mandatory warrants but rather as guidance. Based on this figure, 20 or more pedestrians crossing per hour would be cause for considering the installation of a PHB. The pedestrian crossing data does not indicate that this high of a volume of pedestrians crossing is likely at any single crossing location during one hour. However, since the number of pedestrians crossing is merely a factor for guidance and not a firm warrant, the use of a PHB was considered further as an option to improve pedestrian safety and address the inadequacy of gaps in vehicular traffic for crossing safely.

Based on this investigation, a PHB is recommended for installation in a single location. Multiple installations were not considered further due to the cost of installation as well as the goal to preserve vehicular flow throughout the corridor. The amount of delay to vehicular traffic introduced by a single PHB is reasonable in order to provide safe crossing for a high pedestrian crossing location where gaps in vehicular traffic are currently inadequate to cross safely.
