Final Report

Hwy. 91 STEP Innovation Study (Jonesboro) (S)

HIGHWAY 91 STEP INNOVATION STUDY (Jonesboro) (S)

FINAL TRAFFIC REPORT

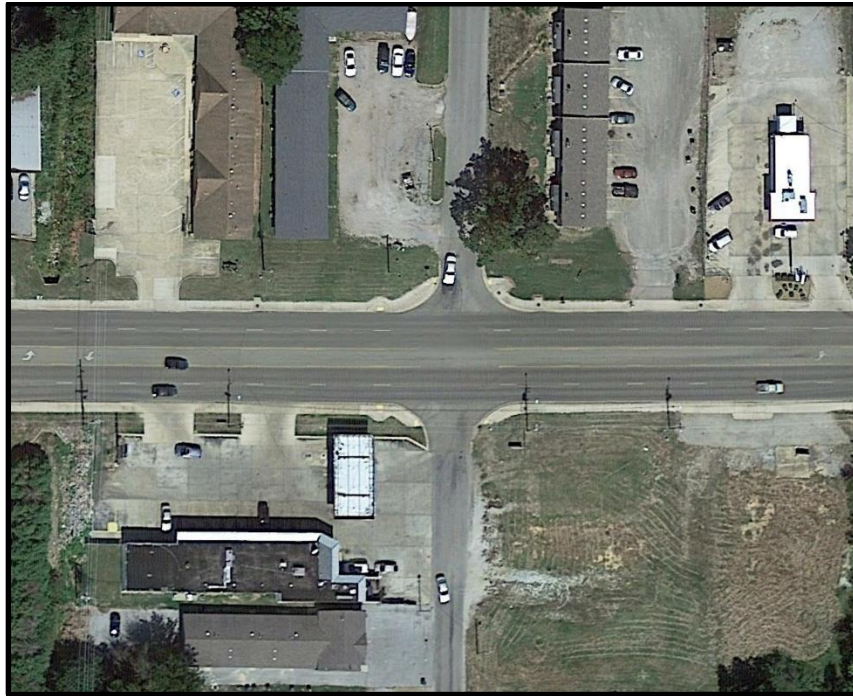
Figure 1: Highway 91 and State Street Intersection

The intersection of Highway 91 and State Street is a four-leg intersection with two-way stop control (TWSC) on the minor approaches (State Street). The eastbound and westbound approaches include a left turn lane, a through lane, and shared through/right lane. The northbound and southbound approaches consist of a shared left/through/right lane. The study intersection is shown in **Figure 1** on the following page. **Figure 2** shows a pedestrian crossing Highway 91 on the west leg of this intersection, which is a common occurrence.

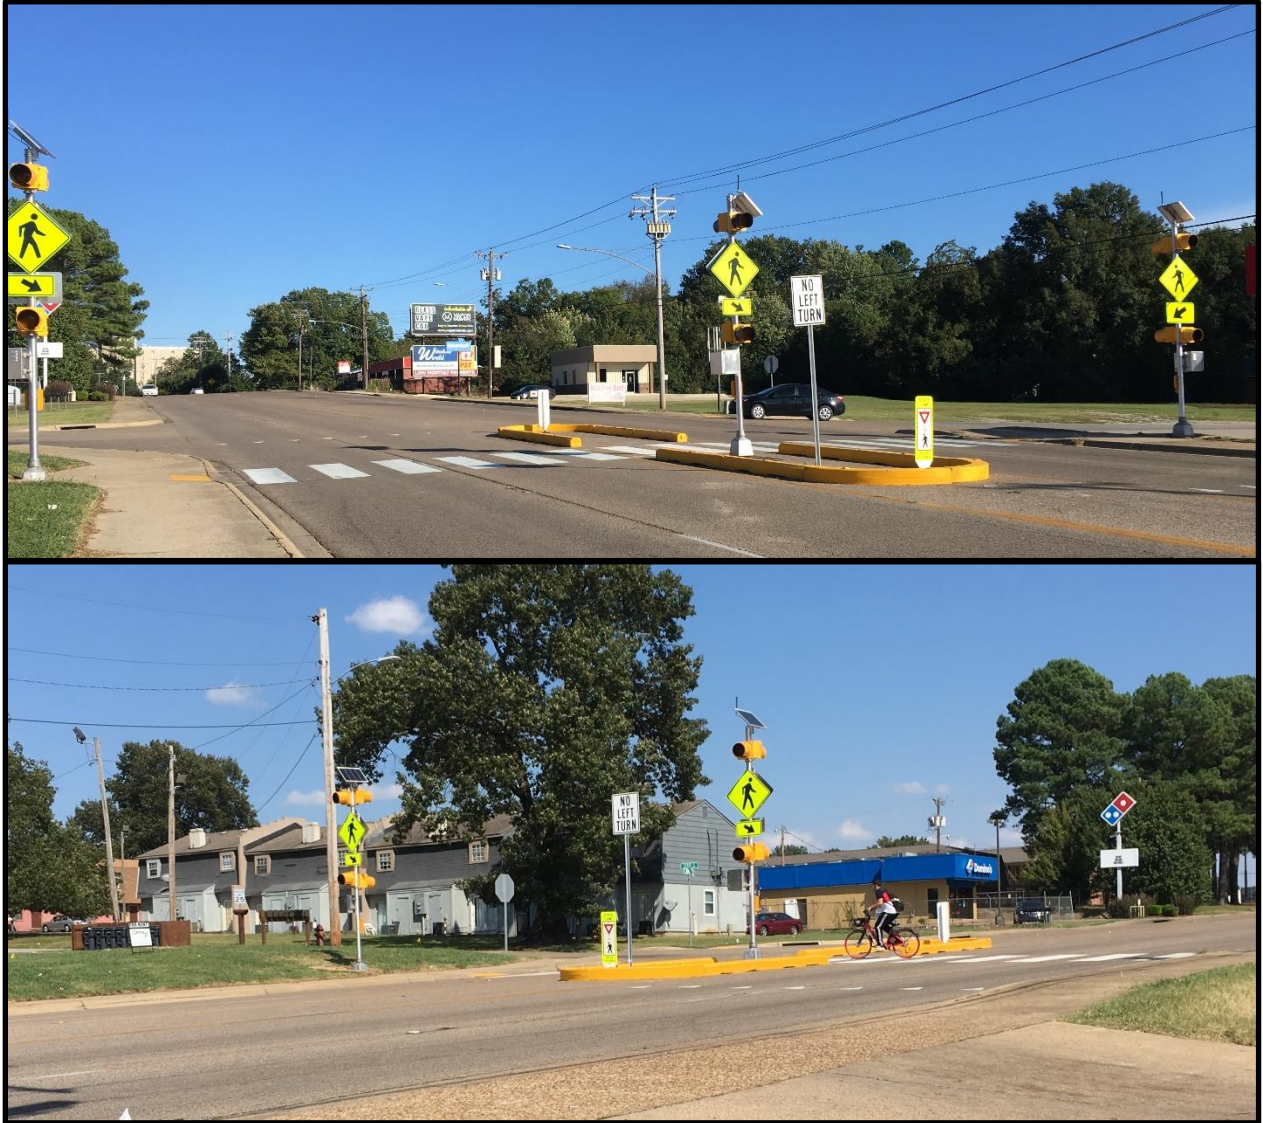
Figure 4: Temporary Pedestrian Crossing across Highway 91

Highway 91 is comprised of two lanes in each direction with a TWLTL. The speed limit is 45 mph, but vehicles often speed through this area. Just west of State Street is a Citgo gas station to the south of Highway 91 and apartment complexes to the north of Highway 91. Pedestrians often cross Highway 91 to go between the gas station and the apartment complexes. The proximity of this site to Arkansas State University also generates heavy pedestrian and bicyclist traffic. Prior to the temporary pedestrian crossing, pedestrians were observed to cross Highway 91 roughly every 5 to 10 minutes throughout the rush hours. These pedestrians often had difficulty finding adequate gaps in traffic. On September 27, 2019, the temporary pedestrian crossing shown in **Figures 4 and 5** was installed across Highway 91 just west of State Street. This crossing has been monitored to determine its effectiveness at improving safety for pedestrians and bicyclists.

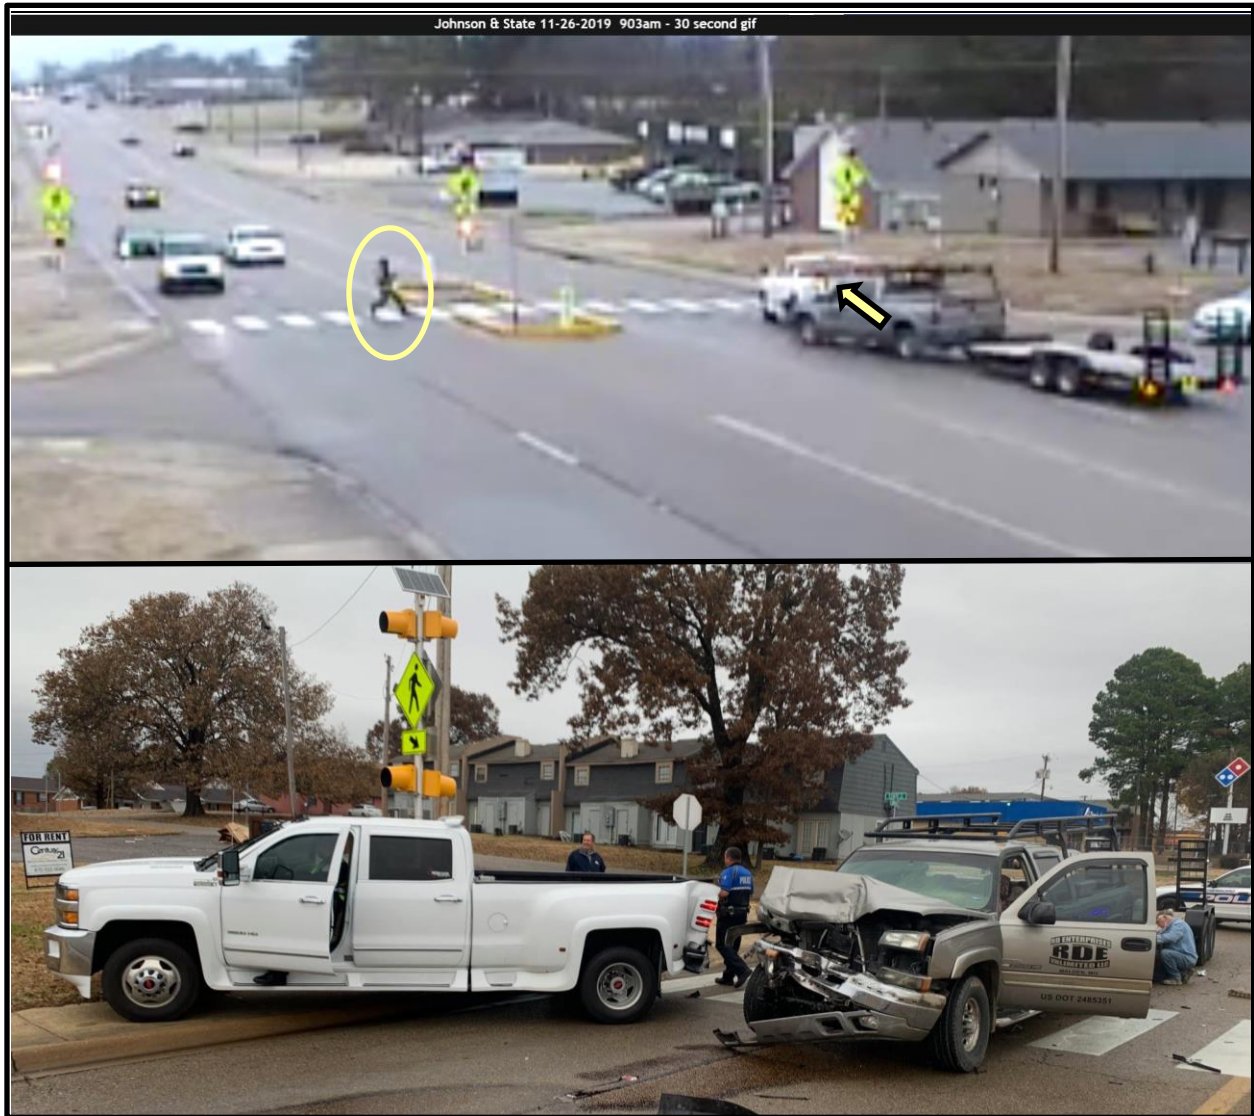
Figure 7: Rear-End Crash on November 26

On November 26, 2019, a pedestrian activated the flashing lights and was nearly half-way across the crosswalk when a speeding, distracted driver rear-ended a truck that was stopped and waiting for the pedestrian to cross. The pedestrian was able to back out of the way of the collision, and nobody was injured. **Figure 7** shows the pedestrian running backwards to avoid this crash in the top picture, and the vehicular damage resulting from the crash in the bottom picture.

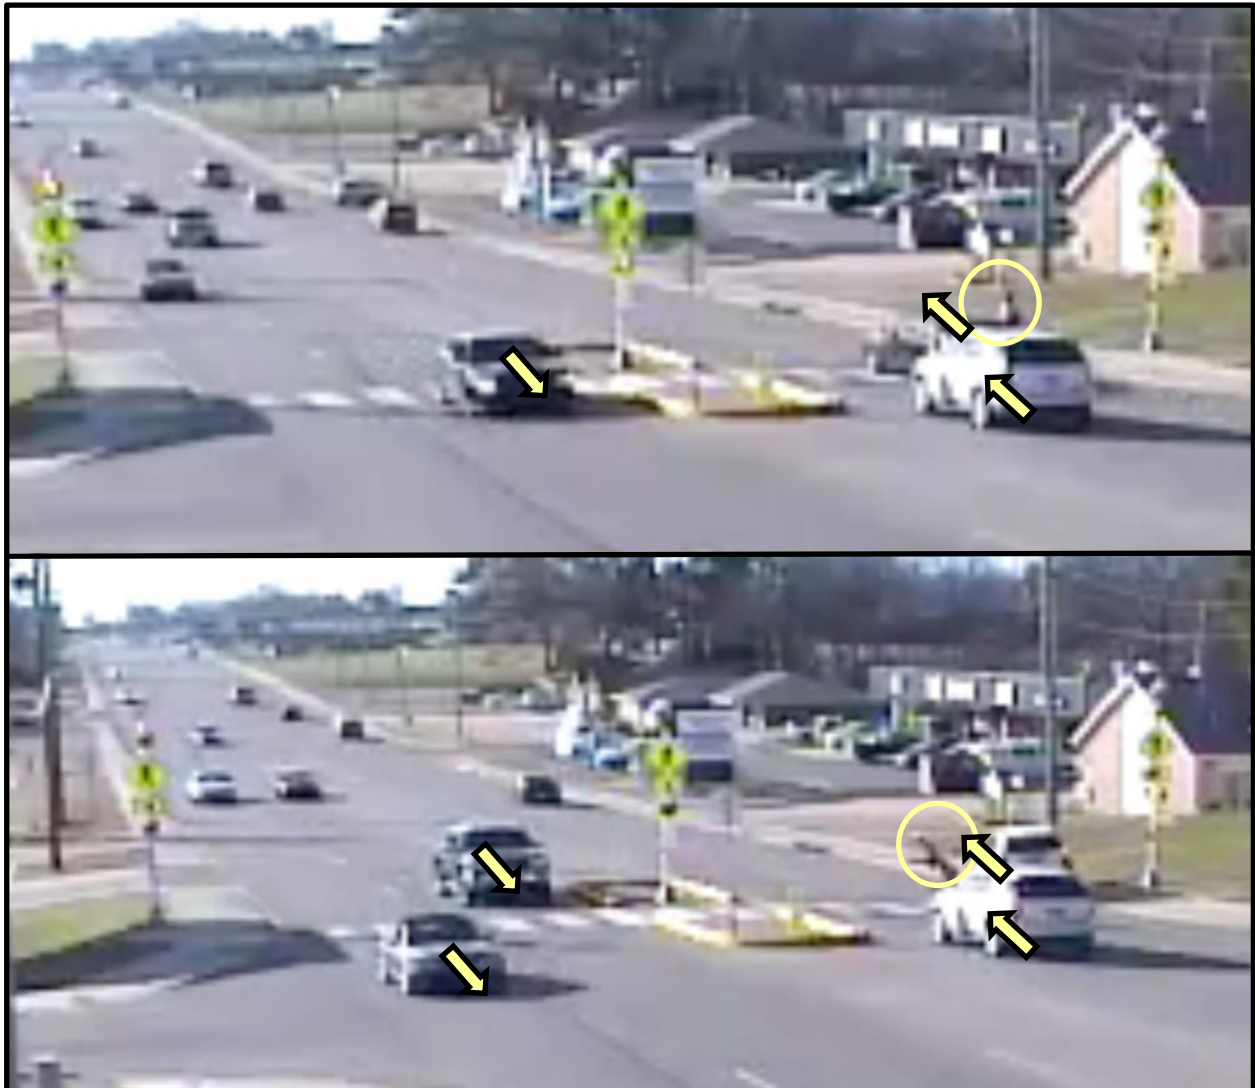
Figure 8: Pedestrian Injury on February 8

On February 8, 2020, over four months after the temporary pedestrian crossing was installed, a pedestrian was hit and injured. The video footage of this incident demonstrates the widespread disregard of motorists for this pedestrian crossing. The pedestrian actuated the light and then had to wait 16 seconds before a driver finally stopped. During that 16 seconds of waiting, 10 vehicles sped through the crossing without

even slowing down. After a vehicle stopped in the inside lane, the pedestrian began to cross, and then two more vehicles sped through the crossing. One of these vehicles narrowly missed the pedestrian, as shown in the top picture of **Figure 8**. Two seconds later, three more vehicles sped through the crossing, and one of these vehicles hit the pedestrian as shown in the bottom picture of **Figure 8**.

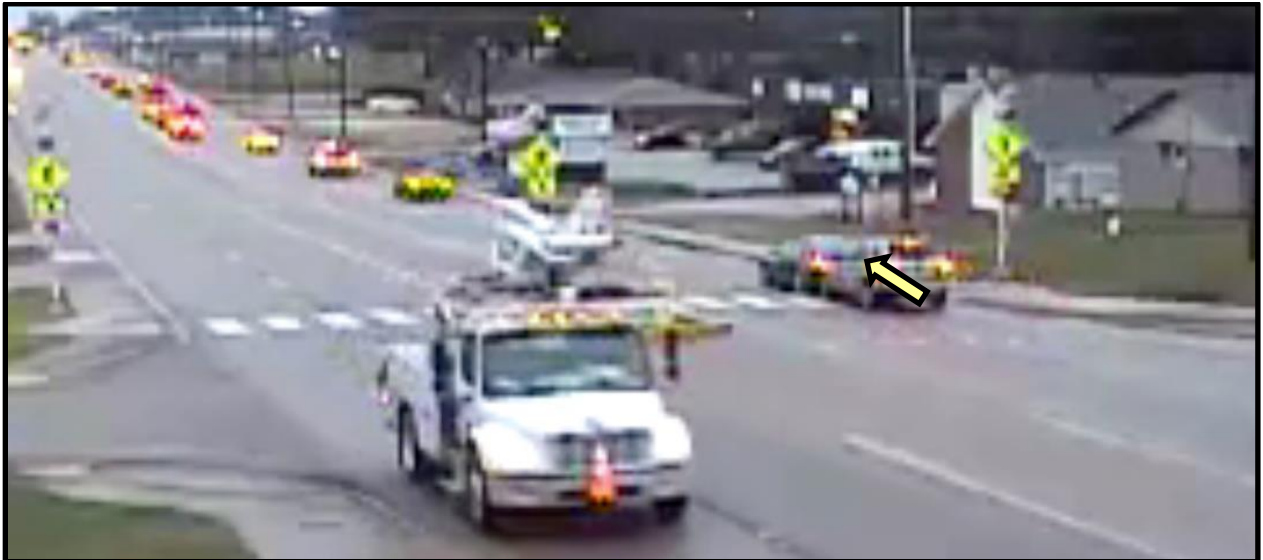
Figure 9: Crash on February 13

On February 13, another rear-end crash occurred at the crosswalk. No injuries resulted, and the cause of the crash did not appear to be related to the pedestrian crossing. Speeding as well as turning into oncoming traffic at the last minute were contributing factors in this crash which is shown in **Figure 9**.

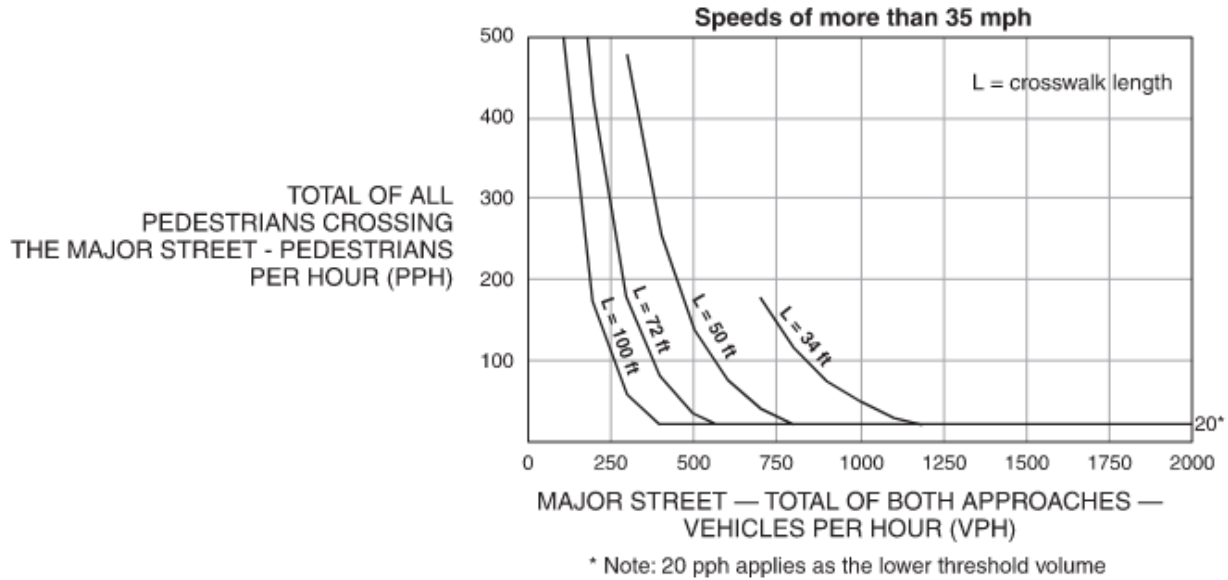
Figure 10: Guidelines for Installation of PHB (MUTCD Figure 4F-2)

The *Manual on Uniform Traffic Control Devices (MUTCD)* provides a table of guidelines for the installation of PHB on high-speed roadways (more than 35 mph) as shown in **Figure 10** on the following page. These guidelines are not meant as mandatory warrants but rather as guidance. Based on this figure, a minimum of 20 pedestrians crossing per hour would be cause for considering the installation of a PHB. Pedestrian crossing data exhibited in **Table 2** show the highest crossing activity occurred across Highway 91 between 4 pm to 5 pm with 27 pph. Hence, a PHB was considered further as an option to improve pedestrian safety and address the inadequacy of gaps in vehicular traffic for crossing safely.
